Crack -Bridging Car Park Flooring **Is it What it is Cracked Up to Be?**

By
Alvin Cheng
CHEMATCO Ltd.

Polyurethane (PU) vs. Epoxy in Crack-Bridging Ability (CBA) on concrete or screeds

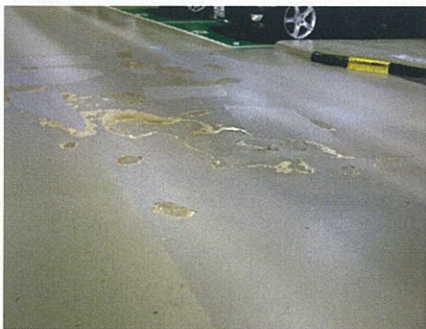
PU floor fails under heavy traffic near car park entrance.

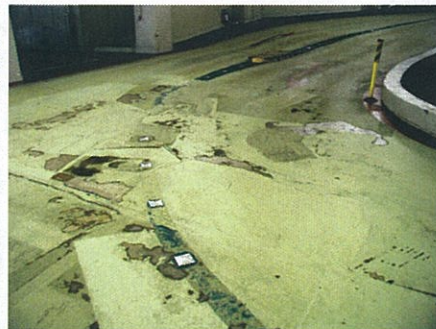
PU floor failure requiring extensive and frequent repairs

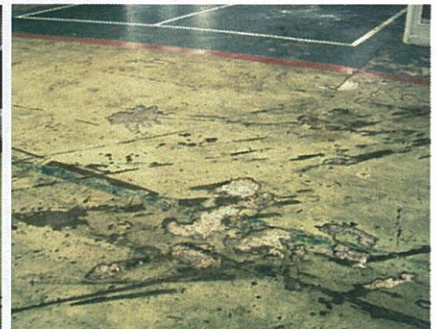
PU floor failure due to wear and tear at a basement car park

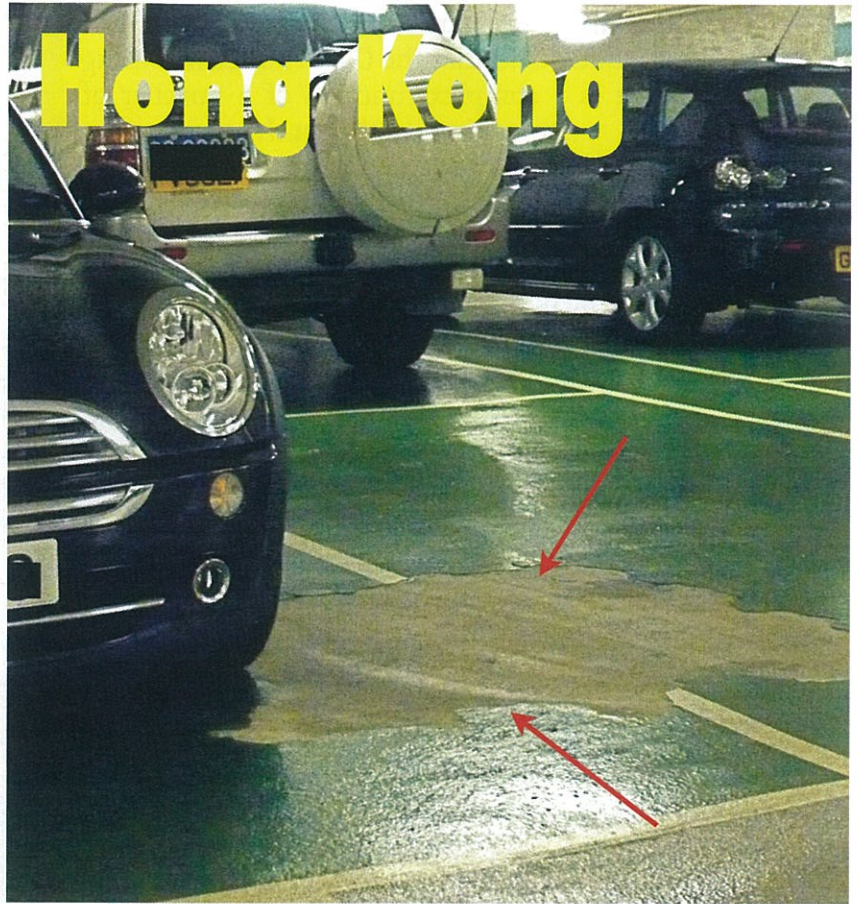
PU or flexible floorings in Hong Kong fail characteristically by wear and peeling off (adhesive failure) from the floor screed in patches. Once small pieces of the coating come off, the process will be accelerated by further wear and tear by the tires. The vulcanized rubber tires create tremendous tearing and stretching action on the floor.

Typical PU flooring failure in Hong Kong where the resilience of the PU coating is no match for the rubber tires.
